10.01.2010

Having submitted my previous letter to your East Area Committee on the **13.11.2009** following your meeting [Mon 9th November 09] I attended as a resident and *supported* Cllr T Martin's comments regarding Health and Safety at/on Hendon Beach and highlighted other major problem with H/S at this site??

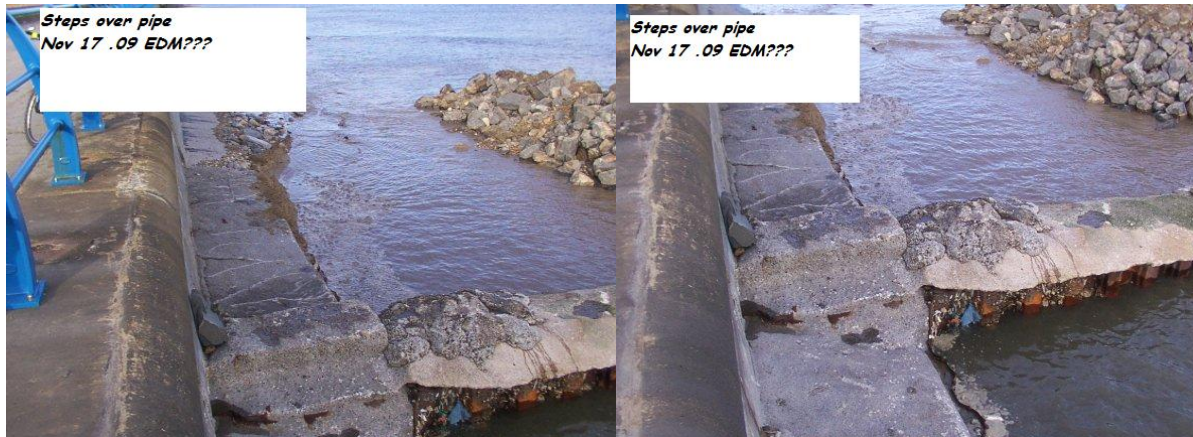
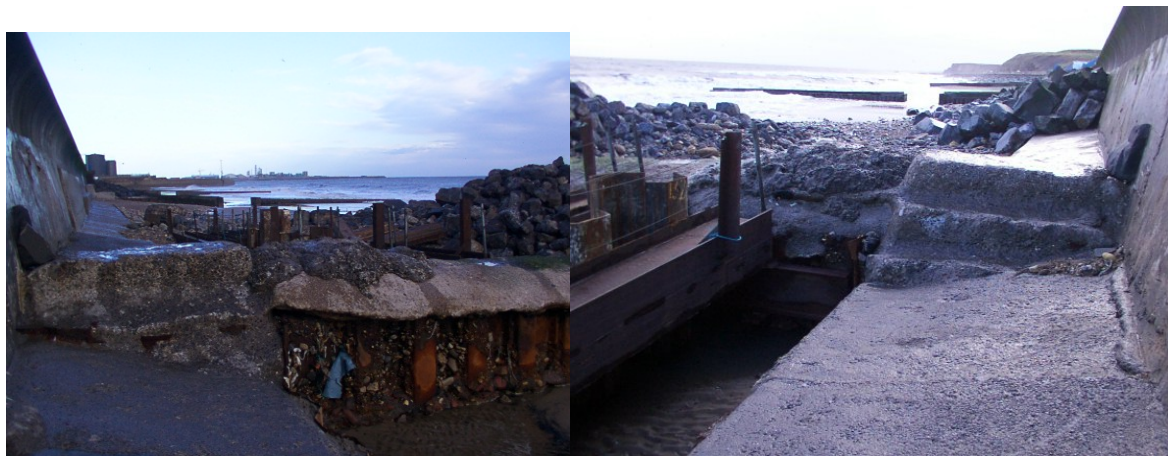
It is now clear to see that these steps could easily be seen they could have been re-capped/re shaped to fulfil the needs of longitudinal access instead of the MAJOR construction now taking place to build ramps over the sewer pipe.

Photographs now show that the new ramp when completed will actually cover the original steps!

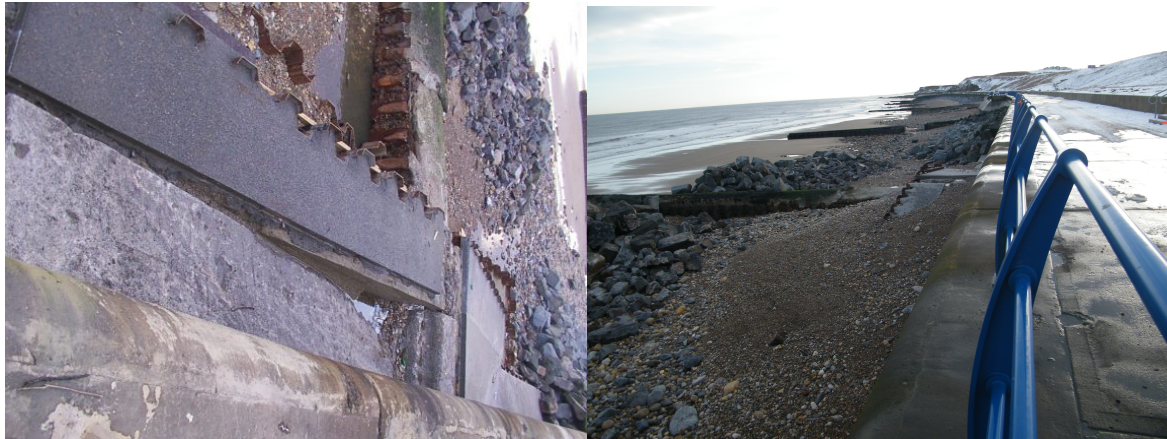
Photographs taken EDM 11.01.2001

It also has to be noted that during/after storms now causes massive movements of sand /gravel so much so what was always sandy beaches now became gravel beds. Actual observers are now seeing sights on the length of the whole beach that have **never** been seen before the destruction of the groyne! This is evidenced by the photograph below of the sand/gravel nearly burying the new ramp and steps??

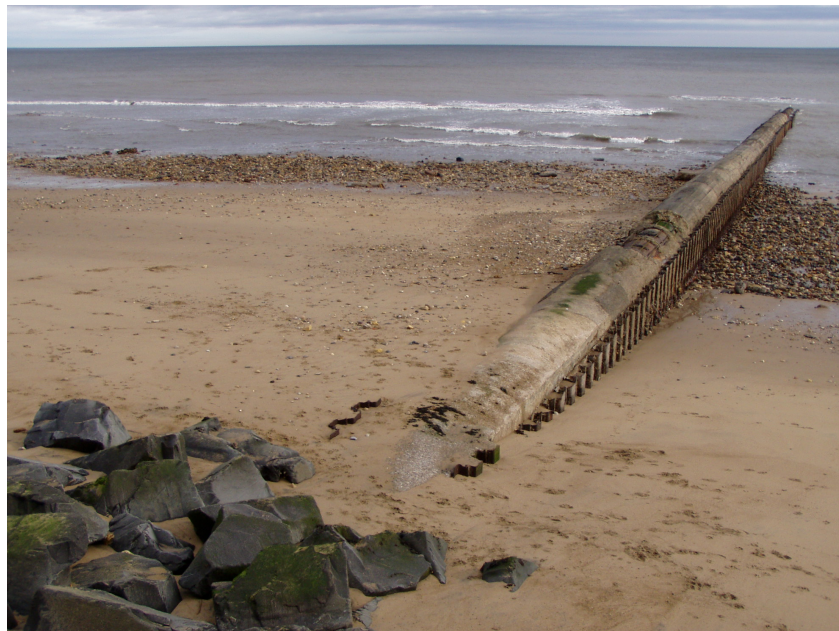
This picture 24.02.09 shows the massive amounts of sand/gravel movement happening **Before** the moving of the Rock Armour at Sewer Pipe for ramp works??? [Grangetown CSO]
